NEW JERSEY STATE DEPT OF ENVIRONMENTAL PROTECTION TRENTON F/G 13/2
NATIONAL DAM SAFETY PROGRAM. WAGAMONS POND (DE00061), DELAWARE --ETC(U)
MAR 79 T T MOORE

REPORT DOCUMENTATION PAGE		READ INSTRUCTIONS BEFORE COMPLETING FORM
1. REPORT NUMBER DE00061	2. GOVT ACCESSION NO.	3. RECIPIENT'S CATALOG NUMBER
4. TITLE (and Subtitle) Phase I Inspection Report National Dam Safety Program Wagamons Pond Dam Sussex County, N.J.	5. TYPE OF REPORT & PERIOD COVERED 9 FINAL rept.

OVERALL VIEW
OF
DAM

NAME OF DAM: WAGAMONS POND DAM

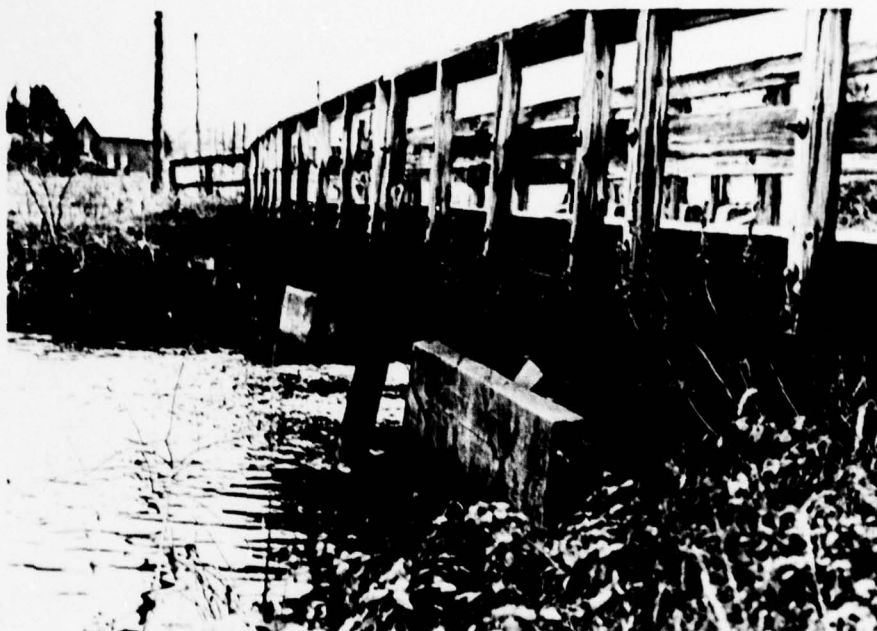
- PHOTO 1 - View of downstream retaining walls - looking south.
- PHOTO 2 - View looking upstream through spillway under bridge.
- PHOTO 3 - View looking southward at columns on downstream side. Note deterioration at low end of first two columns.

- (1) Repair or replace the deteriorated concrete stop log guide columns.
- (2) Repair or replace the downstream embankment retaining walls.
- (3) Regrade and stabilize the downstream slope of the embankment near the bridge. Provide slope protection against future erosion.

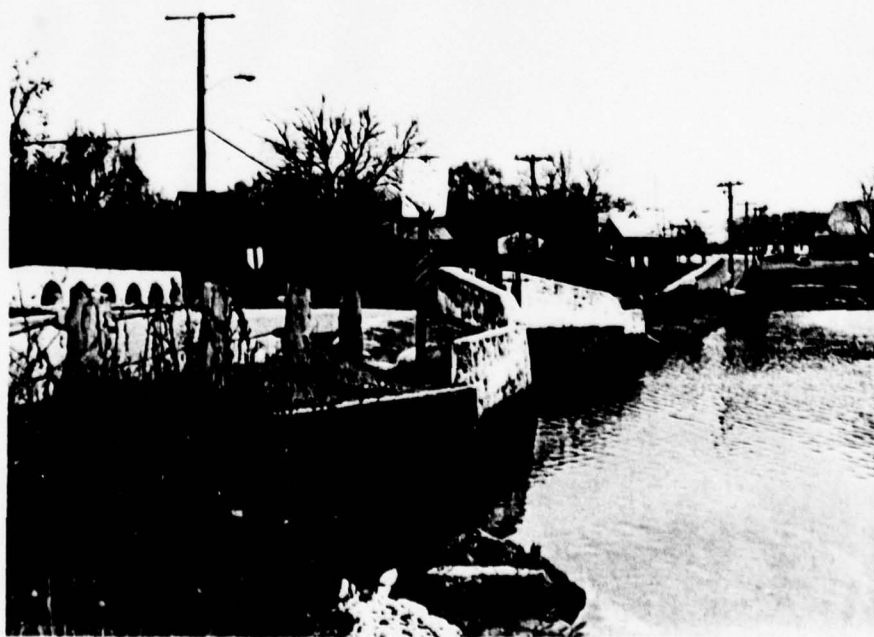
- PHOTO 6 - View of upstream retaining walls - looking south.
- PHOTO 7 - View looking north beyond spillway along embankment.
- PHOTO 8 - View looking south beyond spillway along embankment. Note low point beyond bridge and filled-in mill race on left side.

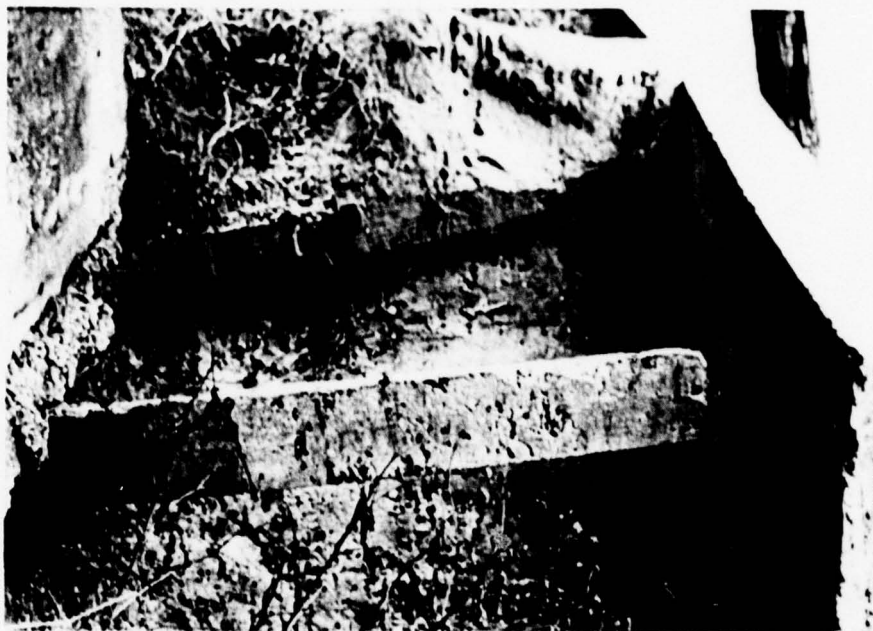
- PHOTO 11 - View of erosion under upper downstream retaining wall on south side of bridge adjacent to sinkhole. Note supporting structure of lower downstream retaining wall.

(2) Repair or replace the downstream embankment retaining walls.

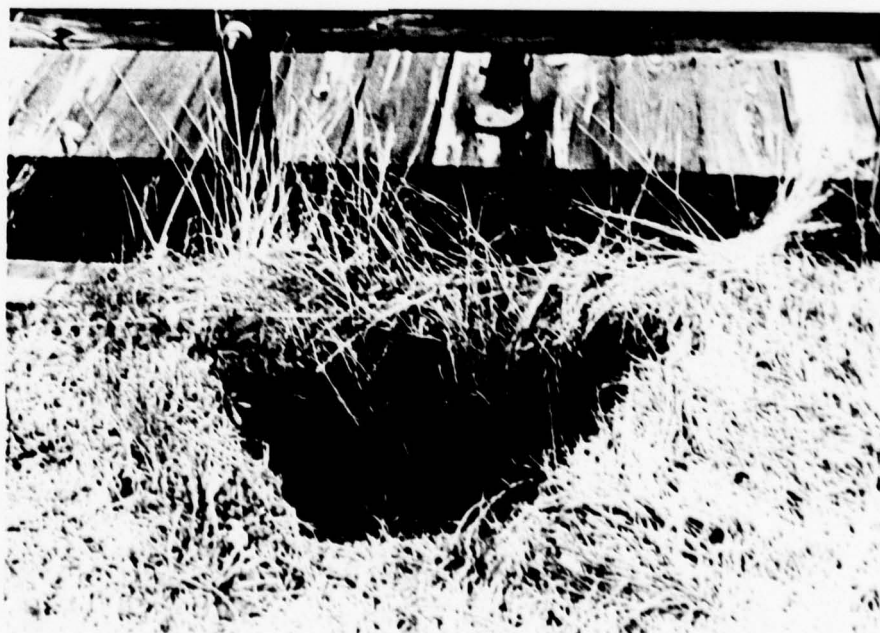
- PHOTO 12 - Close-up of 4 feet diameter sinkhole adjacent to retaining wall noted in Photo 11.
- PHOTO 13 - View looking south at spillway retaining wall and cracked wingwall.
